Lower Your Risk with Concrete Pipe

Lessons Learned from the East Texas Fish Hatchery Incident

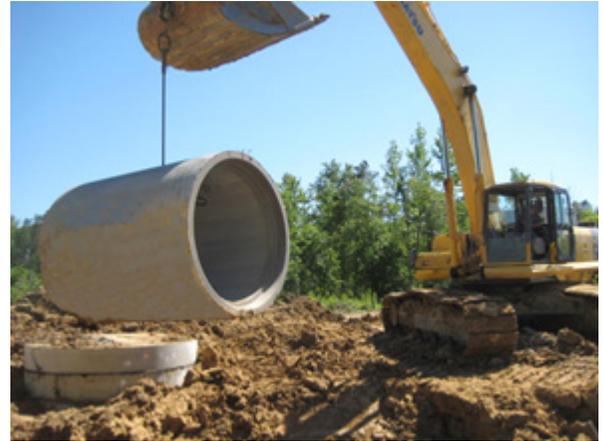
The result of ignoring the structural design and proper installation was front and center at the East Texas Fish Hatchery in 2009. When designers were forced to replace failed drainage pipe with 795 feet of 60" and 2,344 feet of 48" Class V RCP. The failure occurred as a result of an improper installation design based on the site-specific challenges and the selected pipe material. This failure resulted in a \$3.2 million settlement that could have been avoided with proper implementation of the pipe design requirements specific to the selected pipe material in the site-specific conditions.

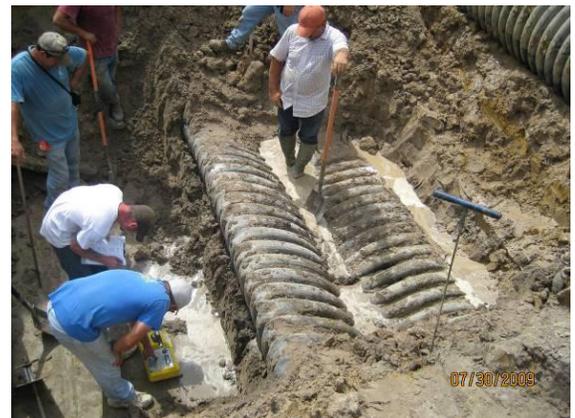
- “The corrugated HDPE drain pipes collapsed or deflected excessively because the external forces imposed by soil and hydrostatic pressures exceeded the capacity of the pipe and surrounding soil to resist those forces.”³

- Insufficient compaction of backfill material was a significant factor in the collapse and excessive deformations.³
- Sufficient compactive effort was not achieved. The gap between the pipe and trench box wall was too narrow to allow proper compaction. Further, dragging the trench box loosened the backfill around the pipe.³

- The Contractor did not comply with the specification requirements for dewatering beneath the pipe trench, which led to difficulty achieving proper compaction of pipe embedment.³
